Contract #: 04-0120F4Cty: SF/ALA Rte: 80 PM: 13.2/13.9File #: 69.28**WELDING INSPECTION REPORT****Resident Engineer:**Pursell, Gary**Address:** 333 Burma Road**City:** Oakland, CA 94607**Report No:** WIR-013767**Date Inspected:** 13-Apr-2010**Project Name:** SAS Superstructure**OSM Arrival Time:** 700**Prime Contractor:** American Bridge/Fluor Enterprises, a JV**OSM Departure Time:** 1900**Contractor:** Zhenhua Port Machinery Company, Ltd (ZPMC), Changxing Island **Location:** Shanghai, China**CWI Name:** Gang Wai**CWI Present:** Yes No**Inspected CWI report:** Yes No N/A**Rod Oven in Use:** Yes No N/A**Electrode to specification:** Yes No N/A**Weld Procedures Followed:** Yes No N/A**Qualified Welders:** Yes No N/A**Verified Joint Fit-up:** Yes No N/A**Approved Drawings:** Yes No N/A**Approved WPS:** Yes No N/A**Delayed / Cancelled:** Yes No N/A**Bridge No:** 34-0006**Component:** OBG COMPONENT**Summary of Items Observed:**

In process Inspection

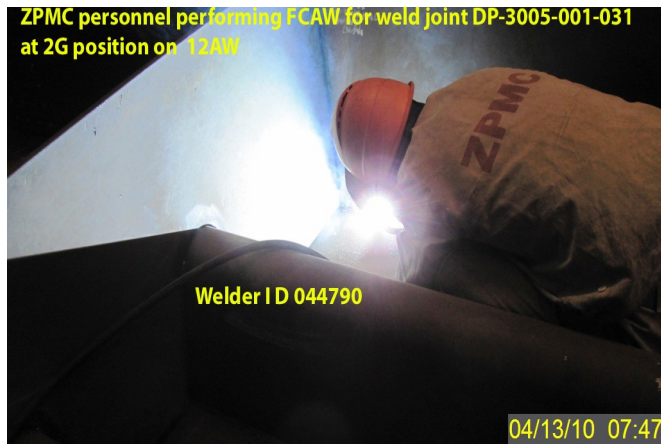
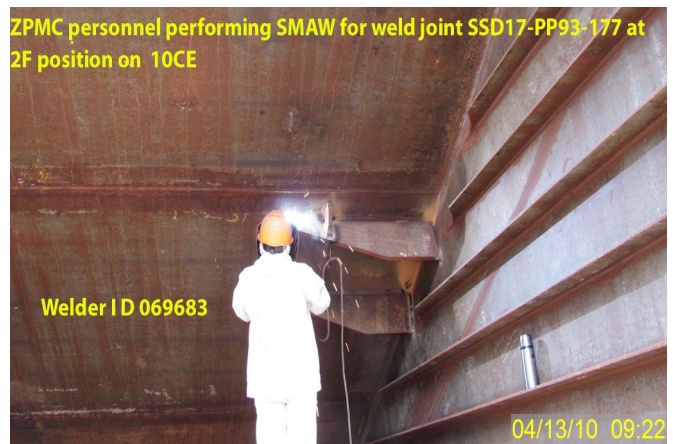
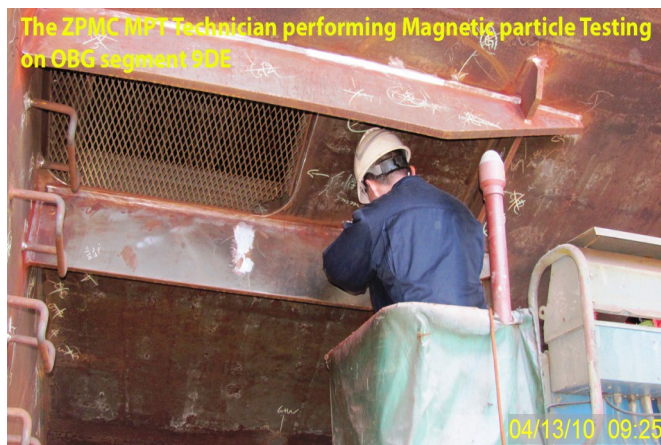
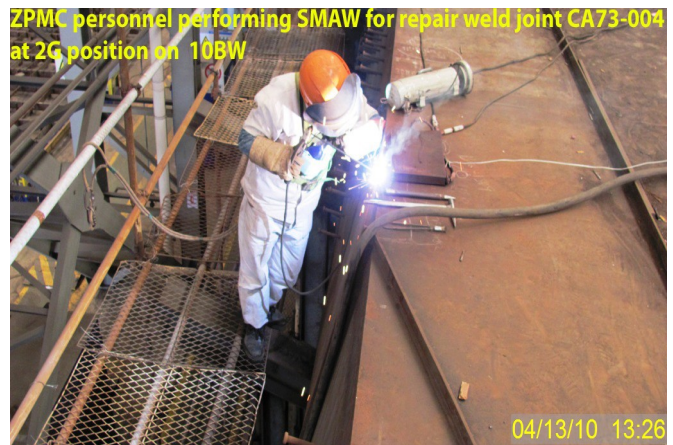
SMAW in the 4F position for the OBG Segment 10CE, weld No.SSD17-PP93-177/178. The welder is identified as #069683. ZPMC QC is identified as Mr. Li Ping. The welding variables recorded by QC appear to comply with WPS-B-P-2114-FCM-1.

SMAW in the 4F position for the OBG Segment 10CE, weld No.SSD17-PP93-201/202. The welder is identified as #067656. ZPMC QC is identified as Mr. Li Ping. The welding variables recorded by QC appear to comply with WPS-B-P-2114-FCM-1.

SMAW in the 3G position for the OBG Segment 10CE, weld No.SSD17-PP93-179 The welder is identified as #050969. ZPMC QC is identified as Mr. Li Ping. The welding variables recorded by QC appear to comply with WPS-B-P-2213-Tc-U4b-FCM-1.

FCAW in the 2G position for the OBG Segment 12CE, weld No.SEG3003S-126. The welder is identified as #050242. ZPMC QC is identified as Mr. Guo Xing Hui. The welding variables recorded by QC appear to comply with WPS-B-T-2232-Tc-U4b-F.

FCAW in the 2G position for the OBG Segment 12CE, weld No.SEG3003S-056. The welder is identified as #044774. ZPMC QC is identified as Mr. Guo Xing Hui. The welding variables recorded by QC appear to comply with WPS-B-T-2232-Tc-U4b-F.

SMAW in the 2G position for the OBG Segment 10BW, weld No.CA073-004. The welder is identified as #051348. ZPMC QC is identified as Mr. Xu Tao. The welding variables recorded by QC appear to comply with WPS-345-SMAW-2G(2F)-FCM-REPAIR-1. The weld repair report is identified as B-CWR-1342.
